**Navigation Study at the Approach
to Lock and Dam 24,
Upper Mississippi River**

**Hydraulic Micro Model
Investigation**

Technical Report M2

Final Report - January 1998

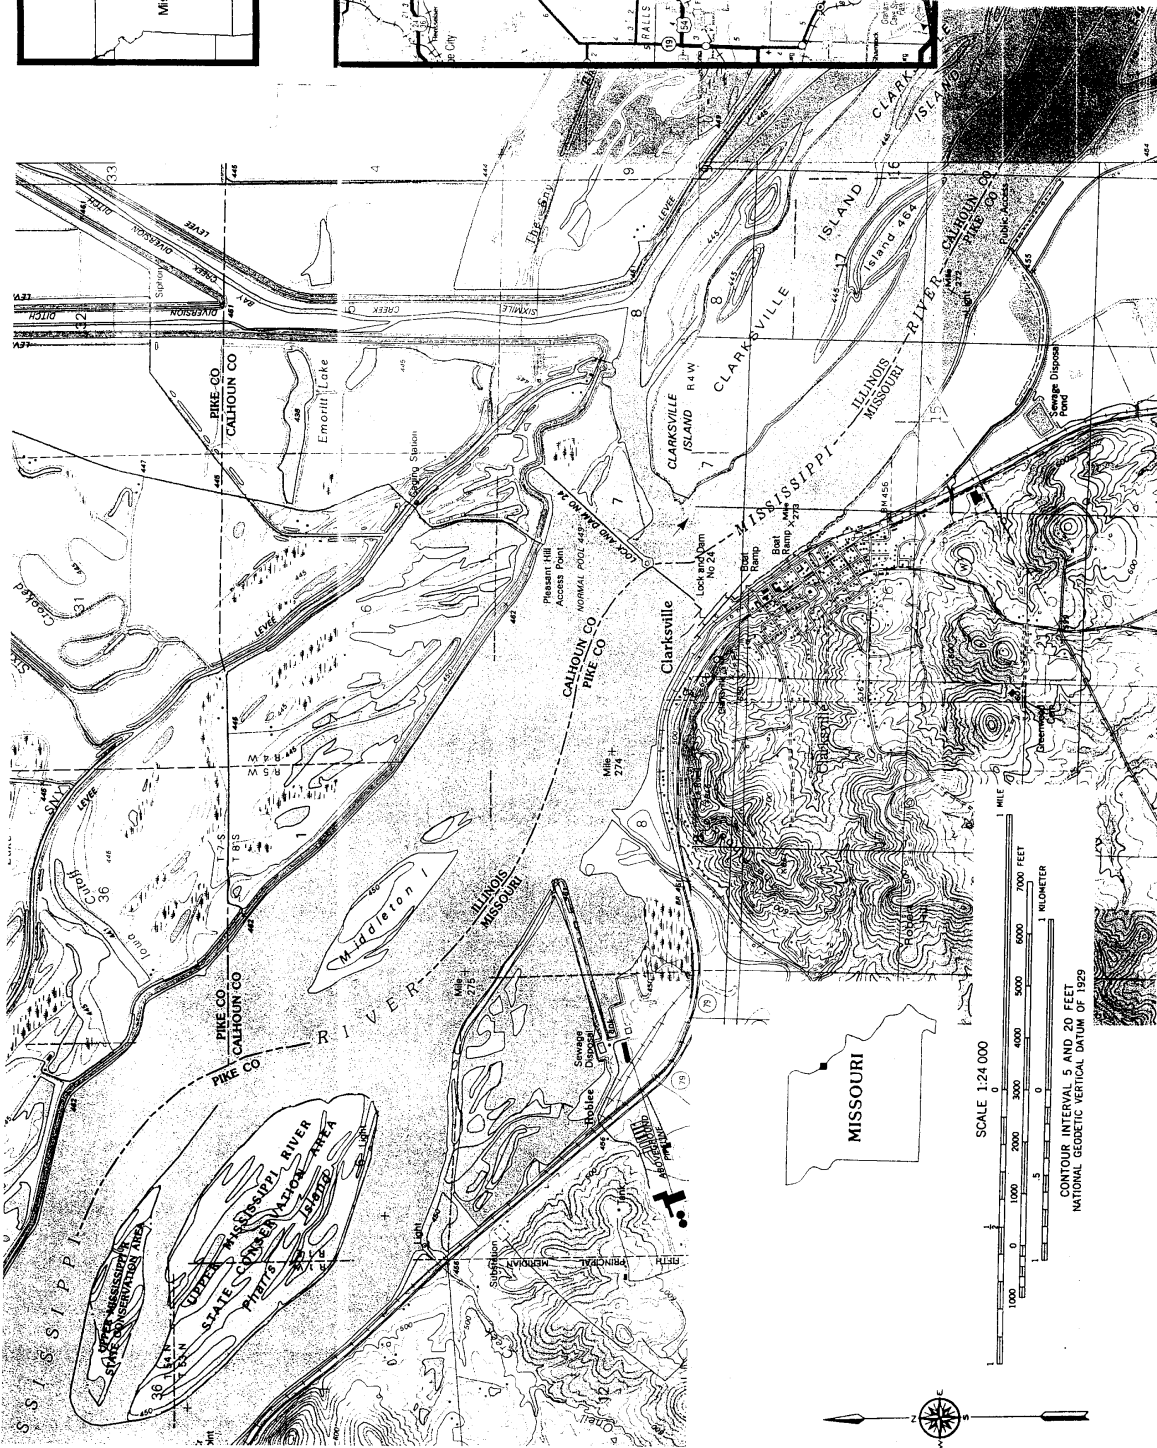
U.S. ARMY ENGINEER DISTRICT, ST. LOUIS CORPS OF ENGINEERS ST. LOUIS, MISSOURI
	Lock and Dam 24 Micro Model Study Mississippi River Miles 271 - 277 Vicinity Map and USGS Quad Sheet of the Study Area

This report details the investigation of a sedimentation and flow study of the Upper Mississippi River using a physical hydraulic micro model. The micro model methodology was used to evaluate detrimental flow conditions experienced at the downbound navigation approach to Lock and Dam 24, Mile 273.5R, at Clarksville, Missouri. Plate 1 displays the vicinity map and USGS quad sheet of the study reach. Plate 2 is a photograph of Lock and Dam 24.
